THE RESIDENT PLAN

A GOLDEN OPPORTUNITY FOR GOLDEN GATE VILLAGE

Presented by the Golden Gate Village Resident Council

January 25, 2022

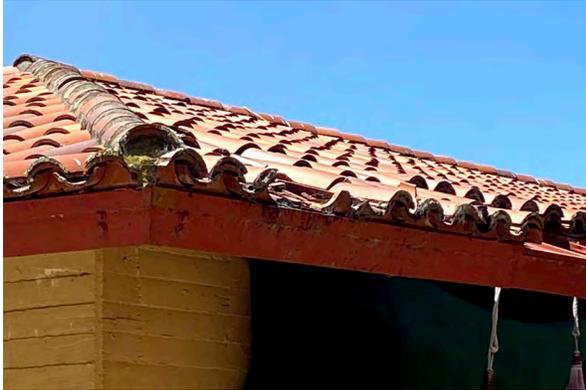
Cracked and missing tiles (Type A - 69 Cole Drive)

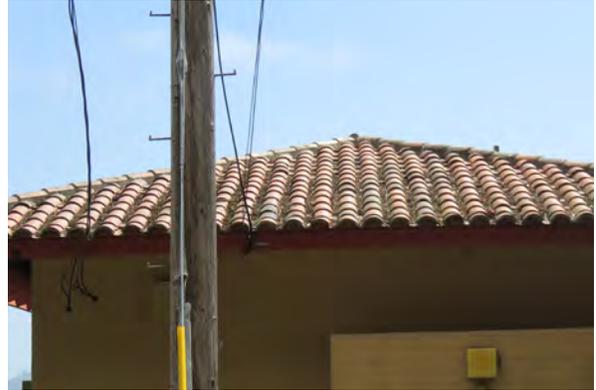
Tree litter (Type A - 419 Drake Ave)

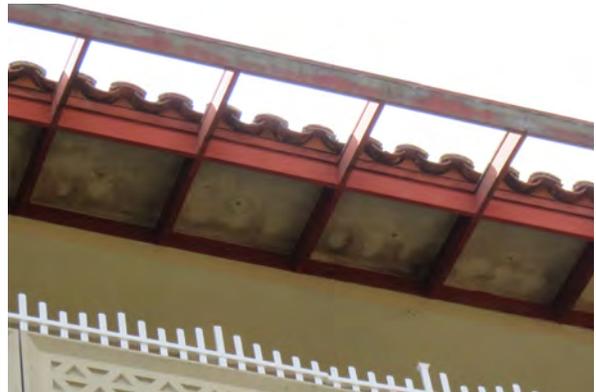
Typical staining on the clay tile roof soffit boards, likely from water damage (Type A - 419 Drake Ave)

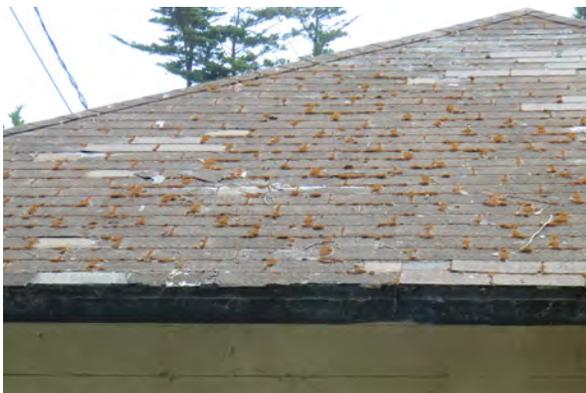
AOMB roof exhibiting cracked, detached, and missing shingles and biological growth

- The roof line and slope were modified on the west side to accommodate the new addition.
- There are several cracked, detached, and missing shingles, leaving parts of the roof membrane exposed. The roof is in poor condition and has exceeded its useful life.
- The roof and fascia are covered in general soiling, biological growth, tree litter, and cobwebs.

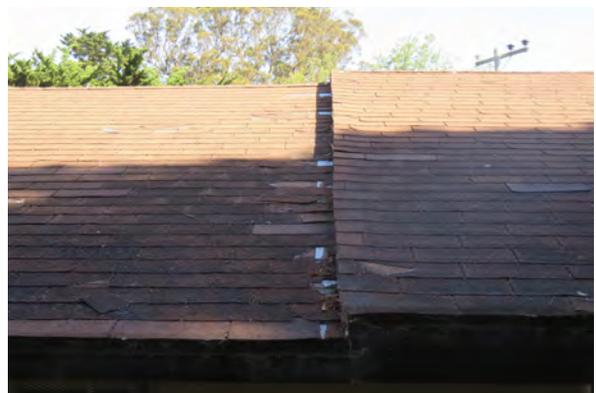
AOMB roof exhibiting cracked, detached, and missing shingles

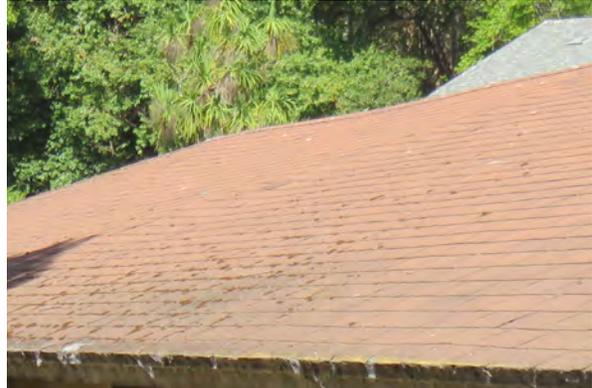
Slope of the AOMB roof distorted where modified to accommodate the new addition on the western end

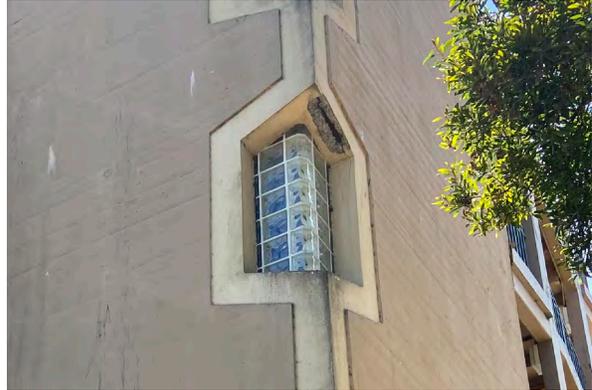
Spalled concrete at a hexagonal stairwell opening (Type A - 69 Cole Drive)

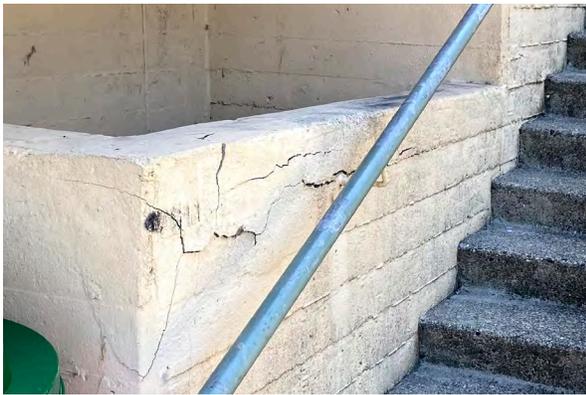
Cracks and patch failure (Type A - 89 Cole Drive)

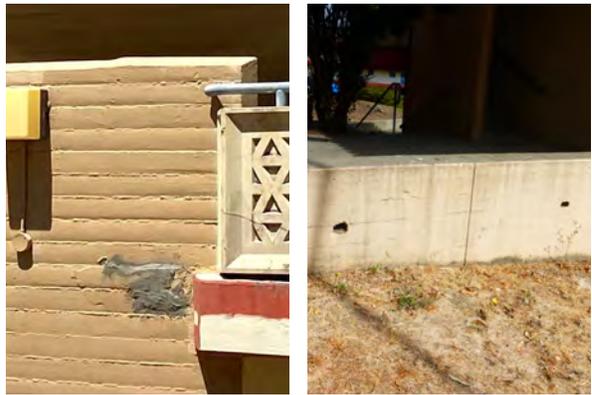
Non-matching patch (Type A - 79 Cole Drive) (left); large holes in a retaining wall (right)

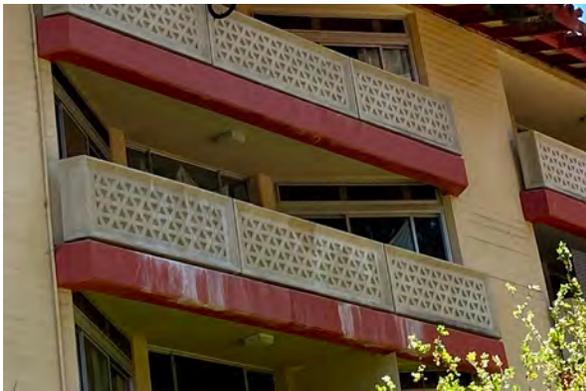
White stains at the balconies (Type A - 79 Cole Drive)

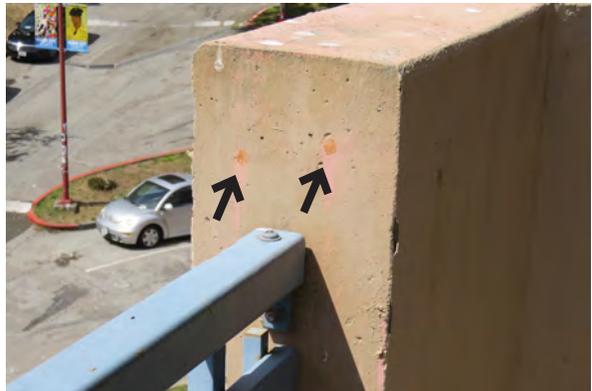
Mild corrosion at exposed rebar in the concrete walls (Type A - 419 Drake Avenue)

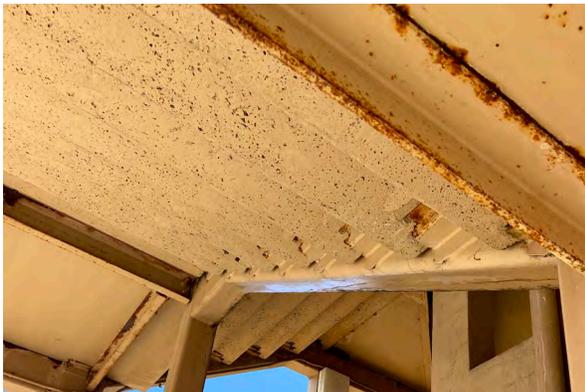
Typical corrosion and paint deterioration at steel-frame staircases of Type A buildings

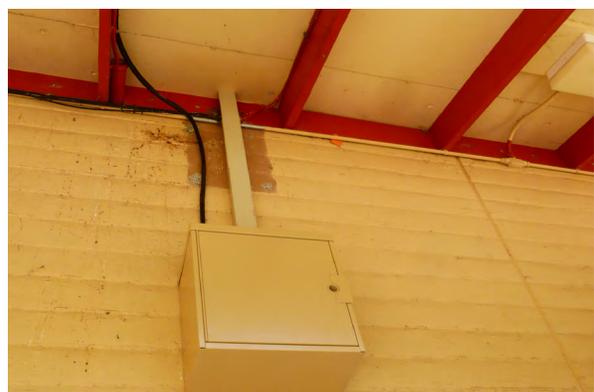
Exposed cabling on building exterior

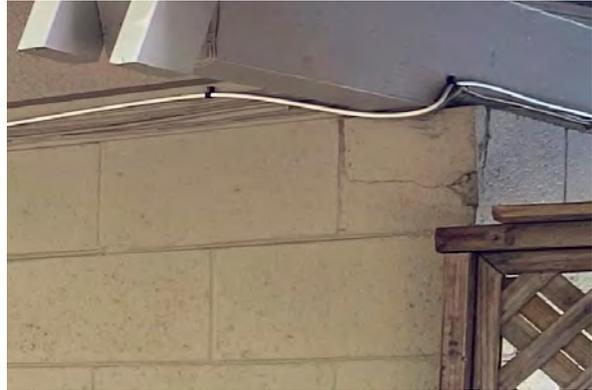
- CMU blocks are in good condition. Some corner blocks exhibit cracks and chipped edges. Some wall areas have been stained by vine growth.
- The wall areas where the lighting fixtures were replaced exhibit old color scheme.
- Wood-framed stucco walls are in fair condition. The wood trims exhibit minor paint deterioration.

Cracked and spalled CMU unit (Type C - 341-47 Drake Ave)

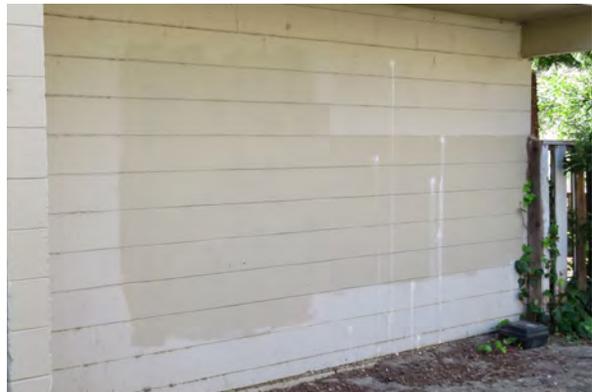
Example of non-matching paint at Type B building, likely an attempt to hide graffiti (62-76 Cole Drive)

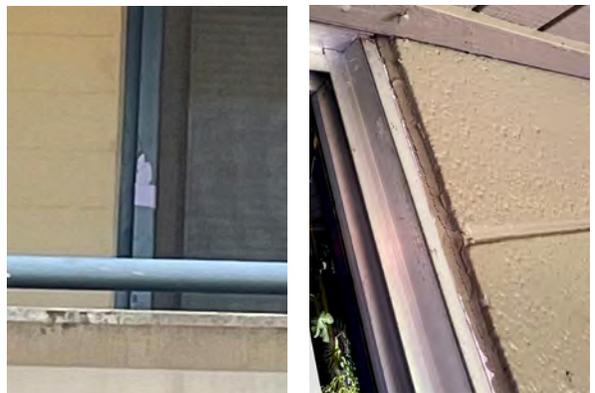
Example of paint deterioration and deteriorated perimeter sealant

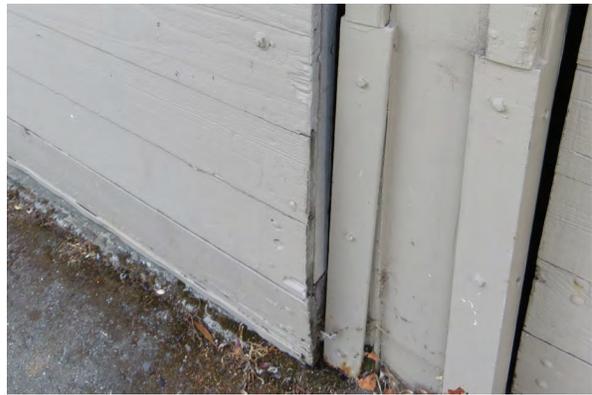
Bowed AOMB garage doors

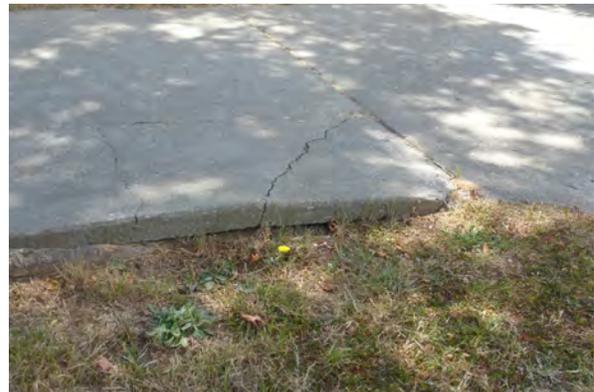
- Concrete walkways and brick pavers in the courtyards between Type B and E buildings are in fair condition. The concrete slabs are cracked and raised at several locations, posing tripping hazards.

Cracked and displaced concrete slab

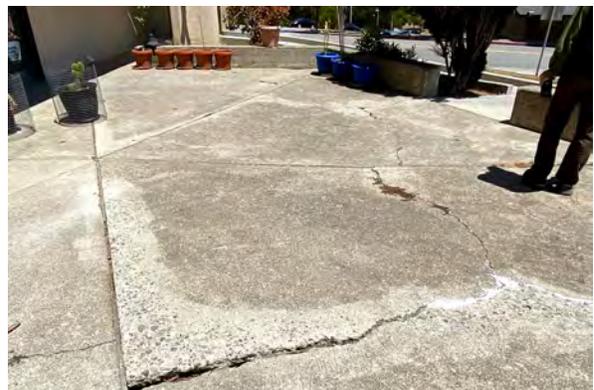
Cracked and displaced concrete slab

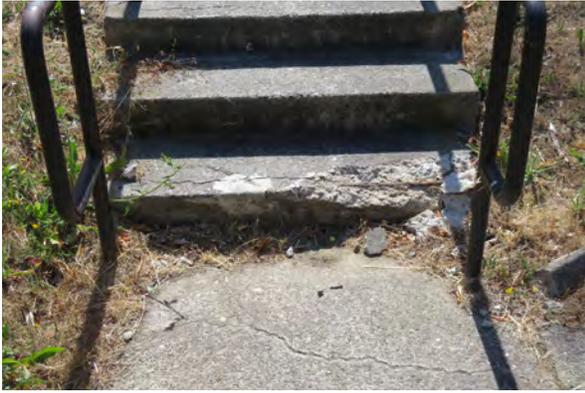
Concrete cracks and spalls and exposed corroded rebar at a staircase

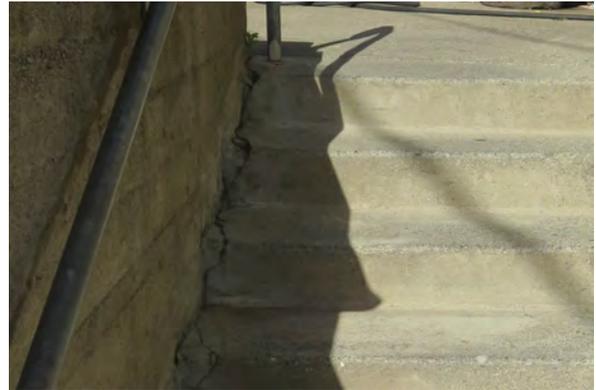
Corner crack at concrete steps

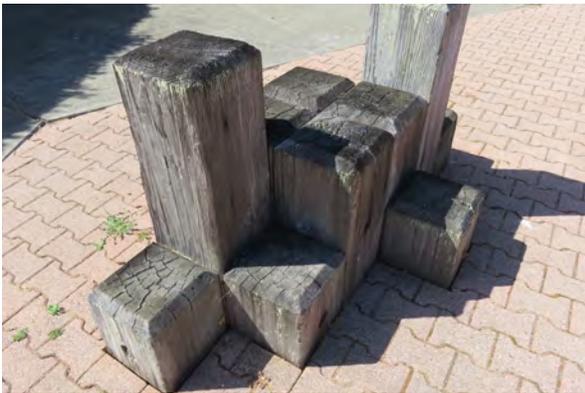
Weathered wood sculptures exhibiting checking, general soiling, and biological growth

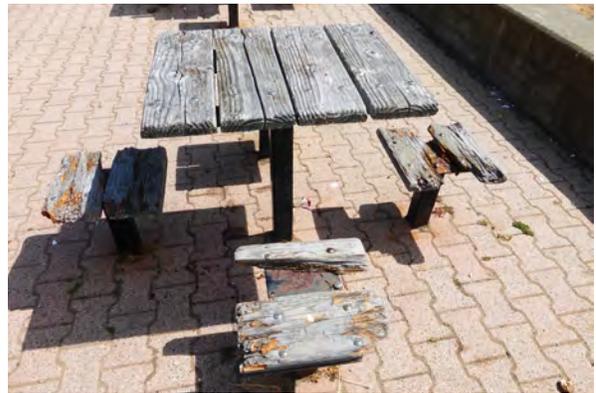
Weathered and deteriorated wood and steel table and benches

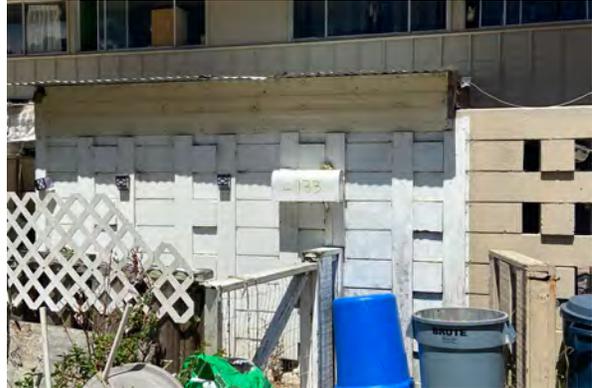
CMU block fence painted and openings filled in with wood (Type B - 121-35 Drake Ave)

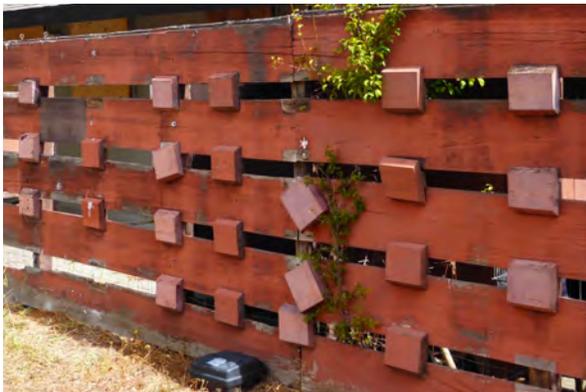
Redwood fence exhibiting missing or displaced ornamentation, checking, paint deterioration, and biological growth

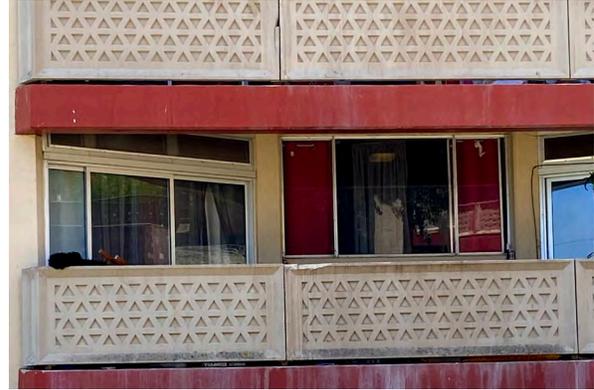
Cracks and spalls in precast concrete screens (Type A - 99 Cole Drive)

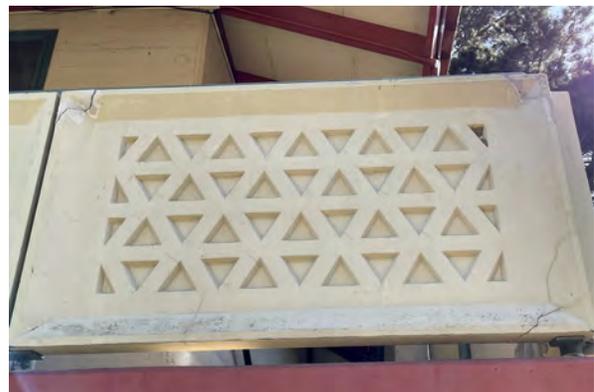
Cracks and spalls in precast concrete screen; note small insect nest at the top-right corner (Type A - 49 Cole Drive)

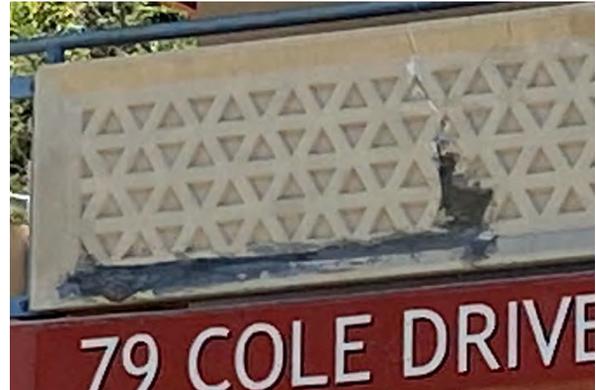
Incompatible patch repair at a composite panel (Type A - 79 Cole Drive)

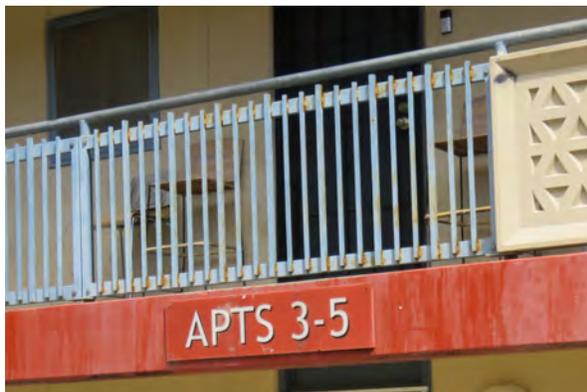
Steel railings exhibiting corrosion and paint deterioration

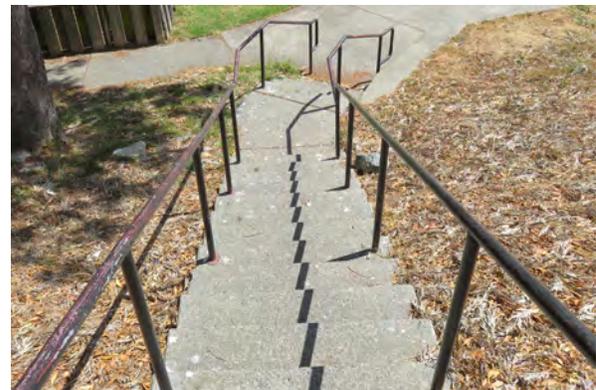
- Metal pipe handrails are in fair condition and exhibit corrosion, paint deterioration, and missing screws.

Typical metal pipe handrail exhibiting corrosion and paint deterioration

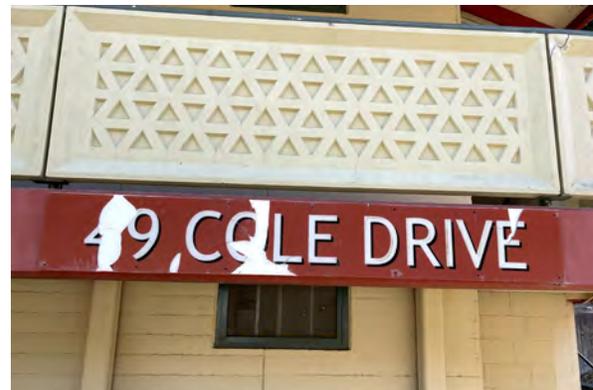
Paint deterioration (Type A - 49 Cole Drive)

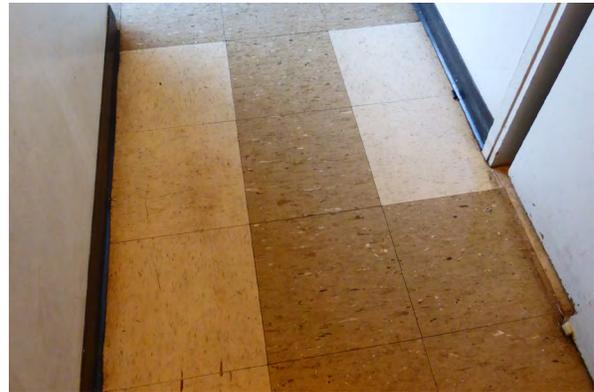
Non-matching resilient tiles at a Type A apartment

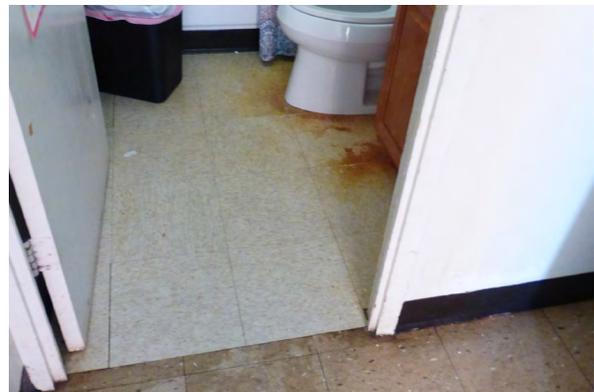
Stained resilient tiles in the bathroom of a Type A apartment

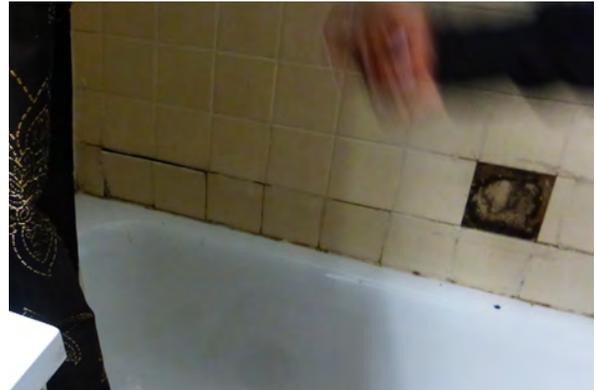
Damaged bathroom tiles at a Type E building apartment

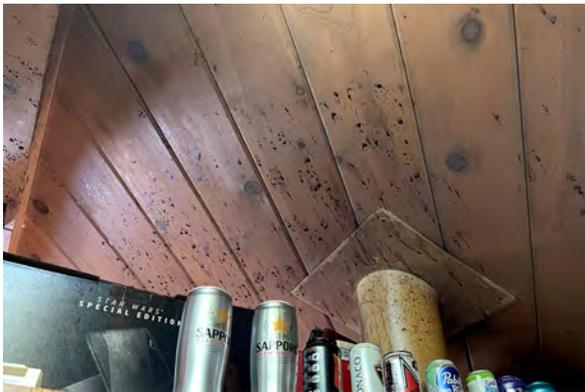
Staining on the ceiling of a Type E apartment, likely from the kitchen grease.

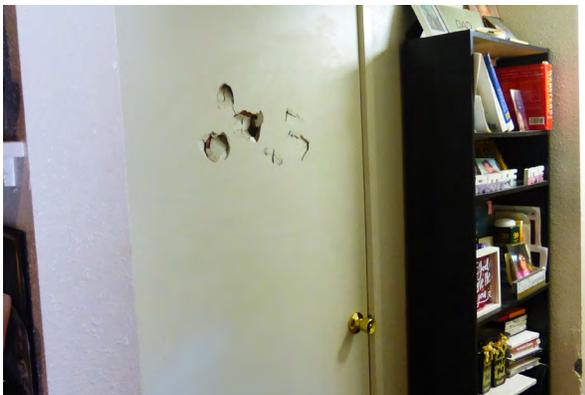
- Some interior wood doors had holes or impact damage.

Wood door damage at a Type C building apartment

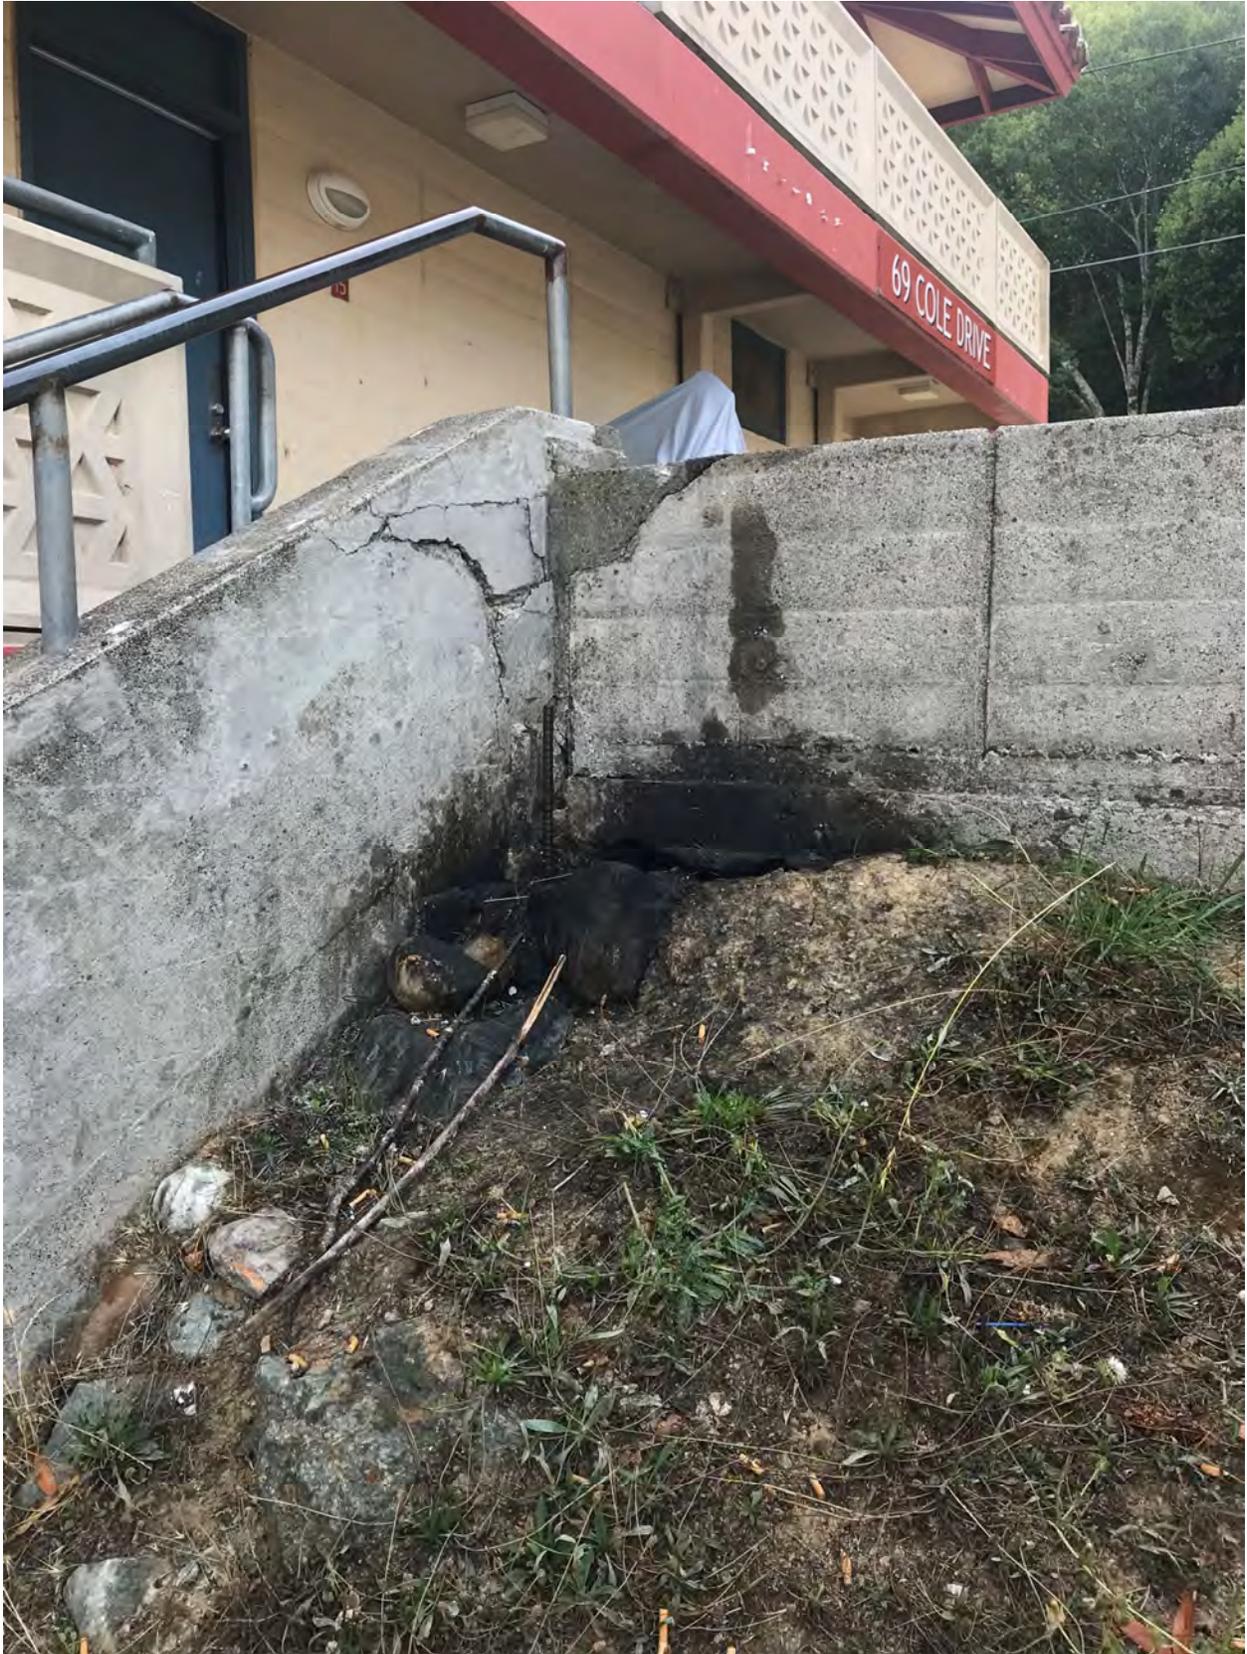
Damaged retaining wall

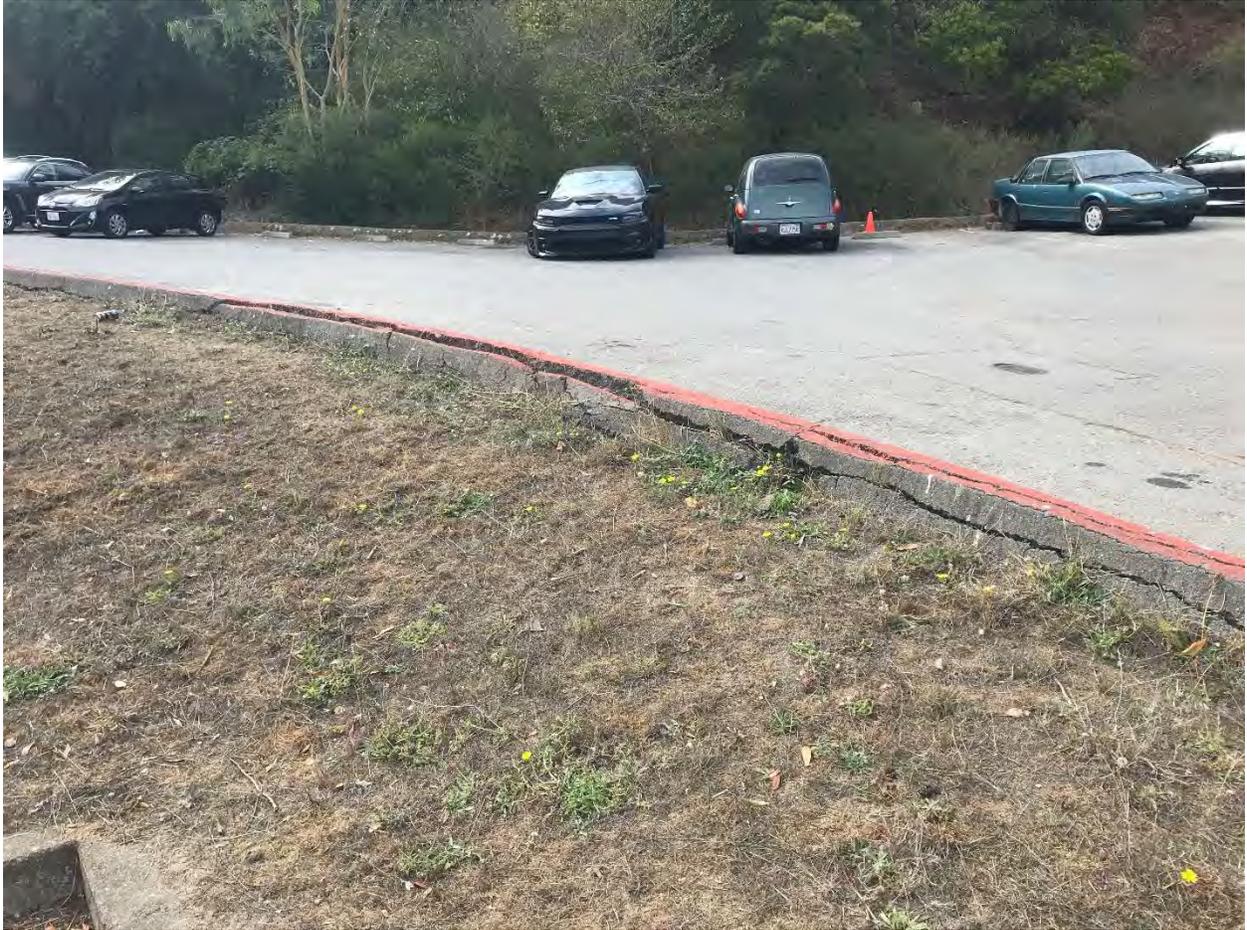
Deteriorated paving

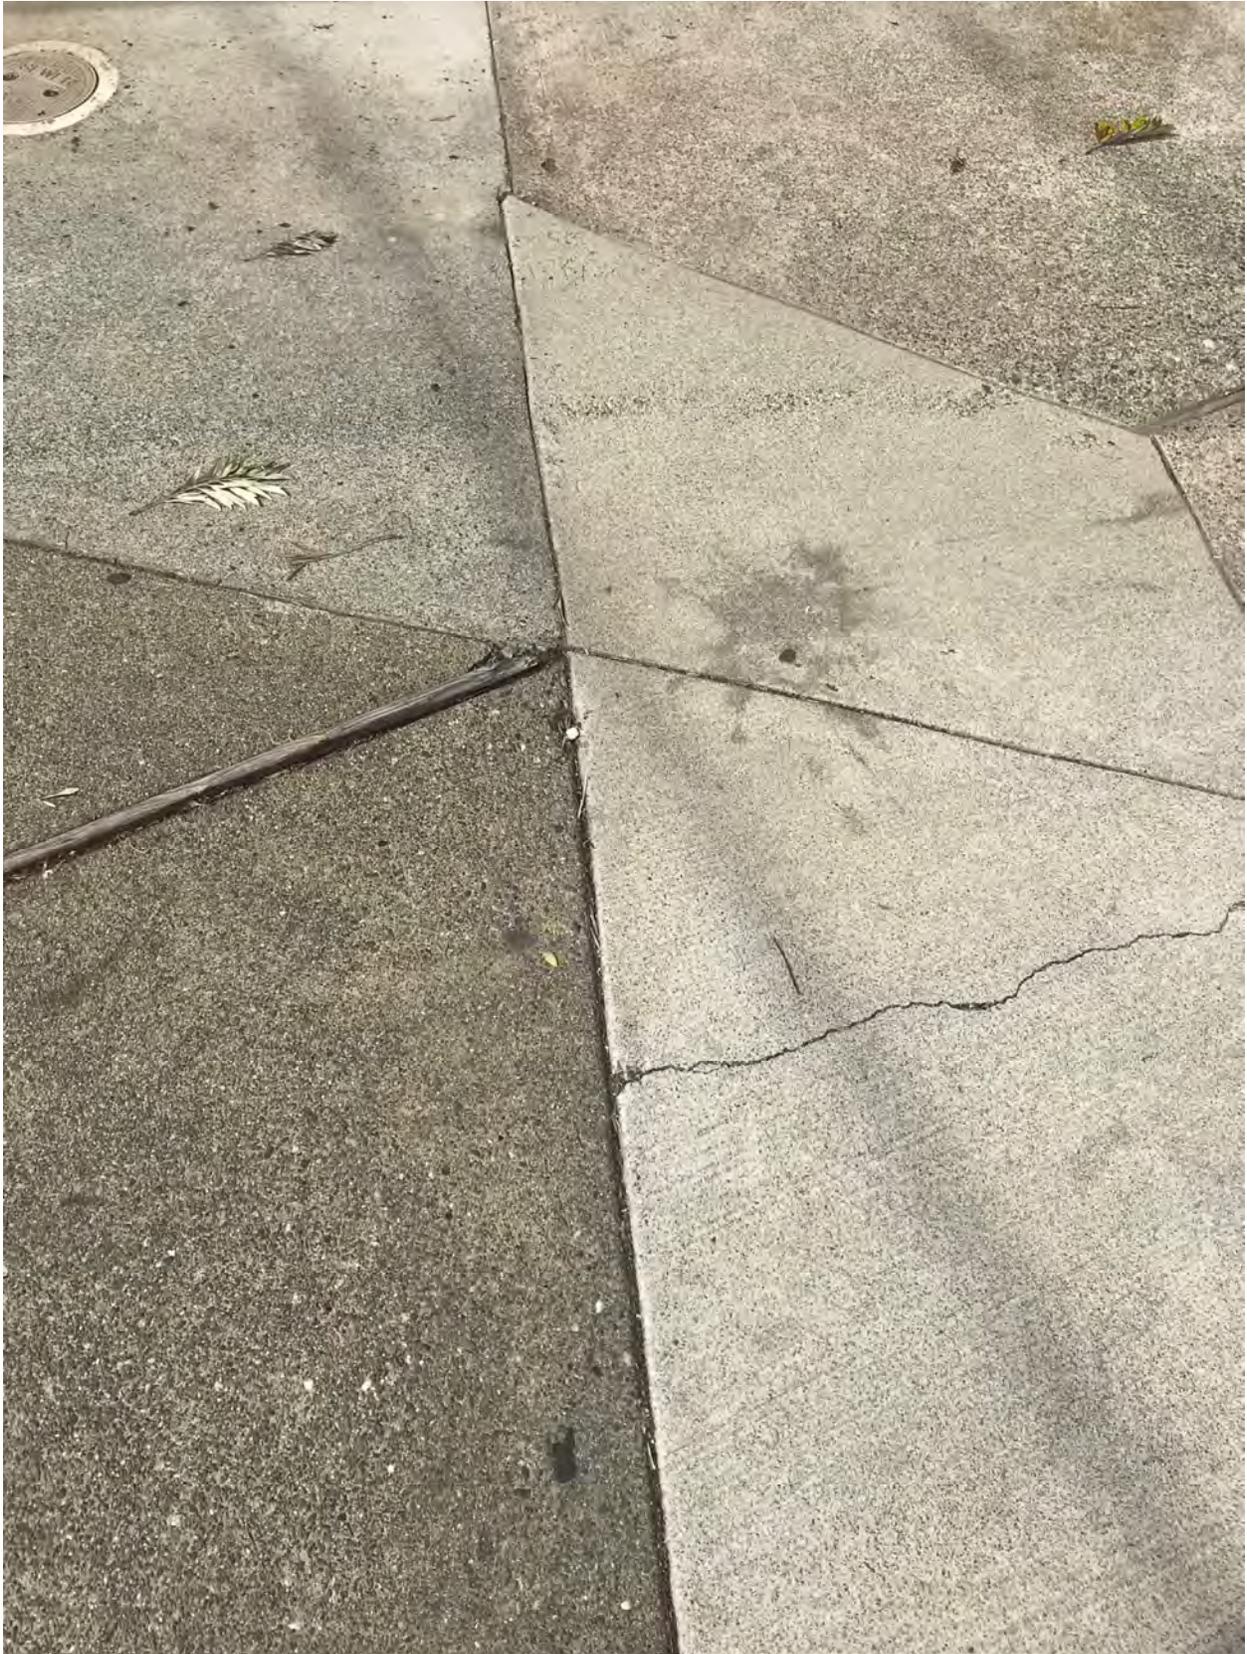
Deteriorated paving, original and replacement

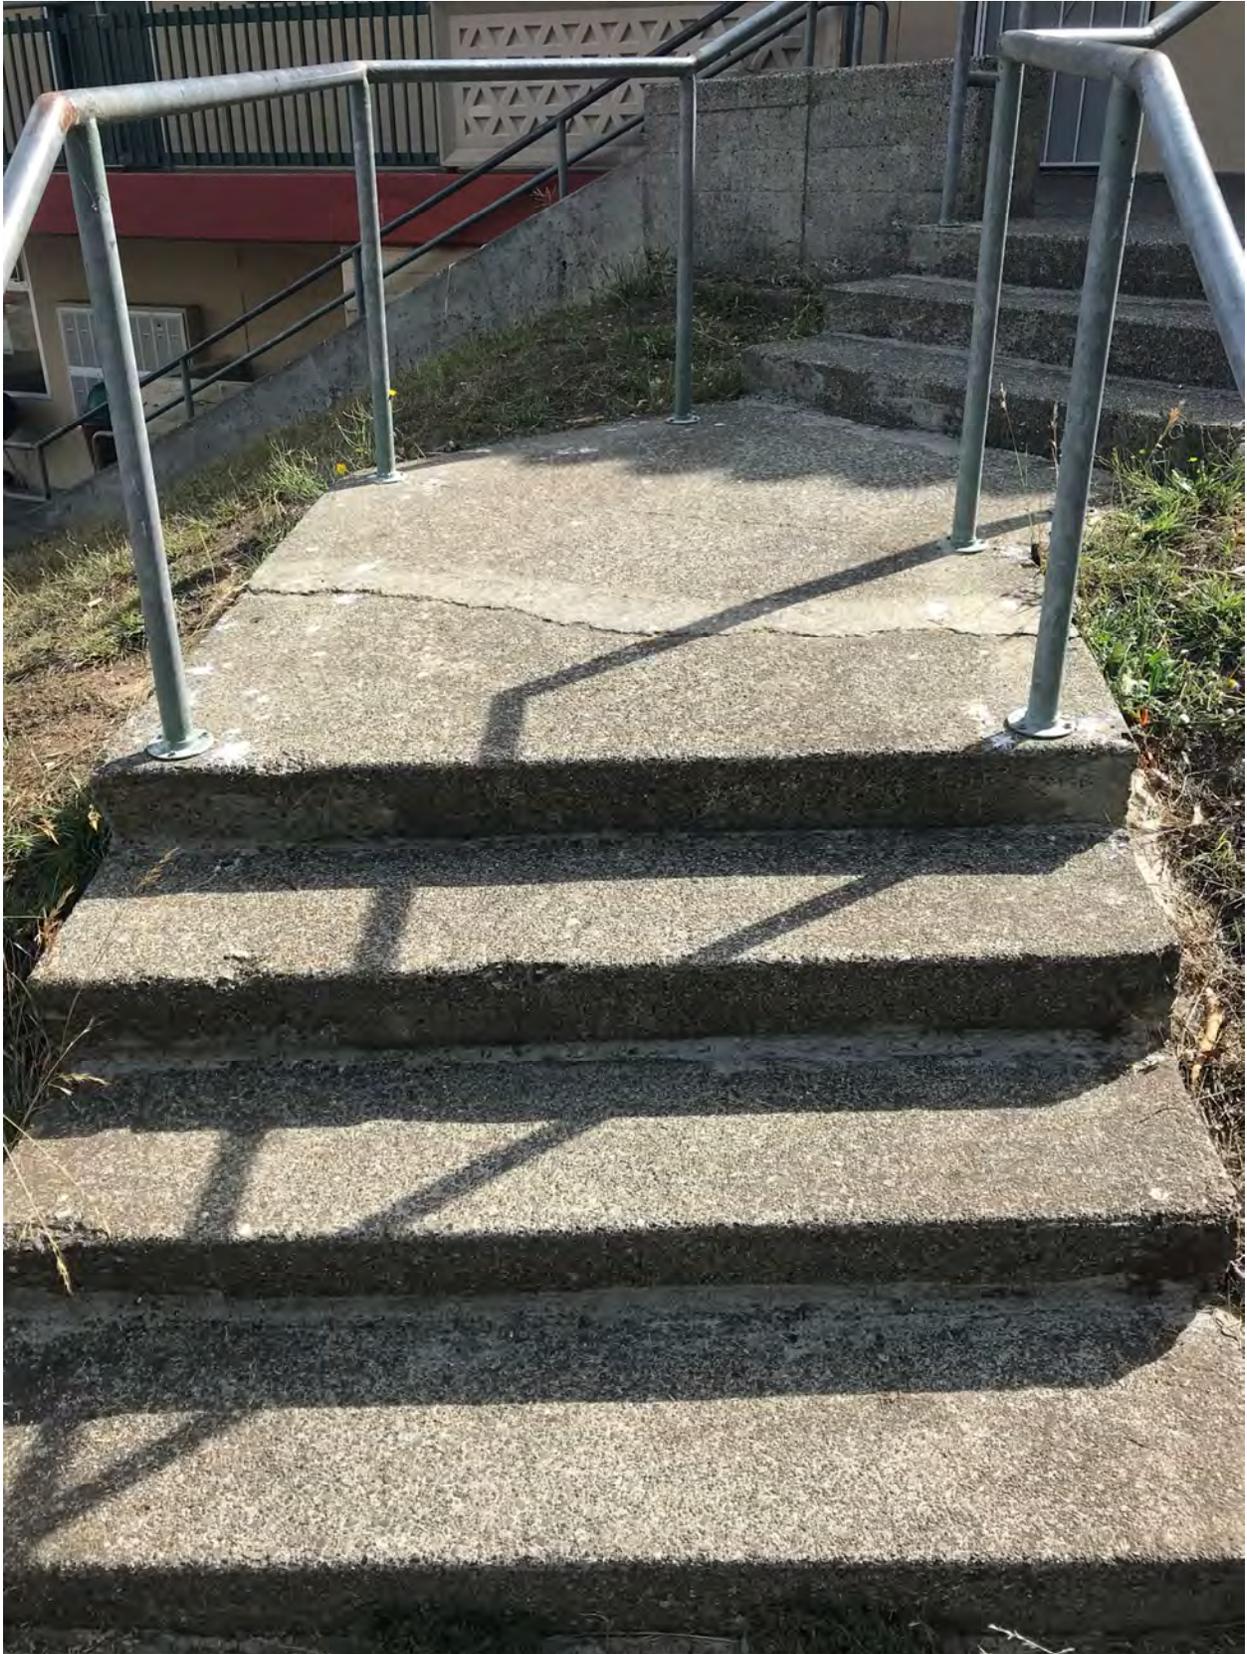
Damaged steps

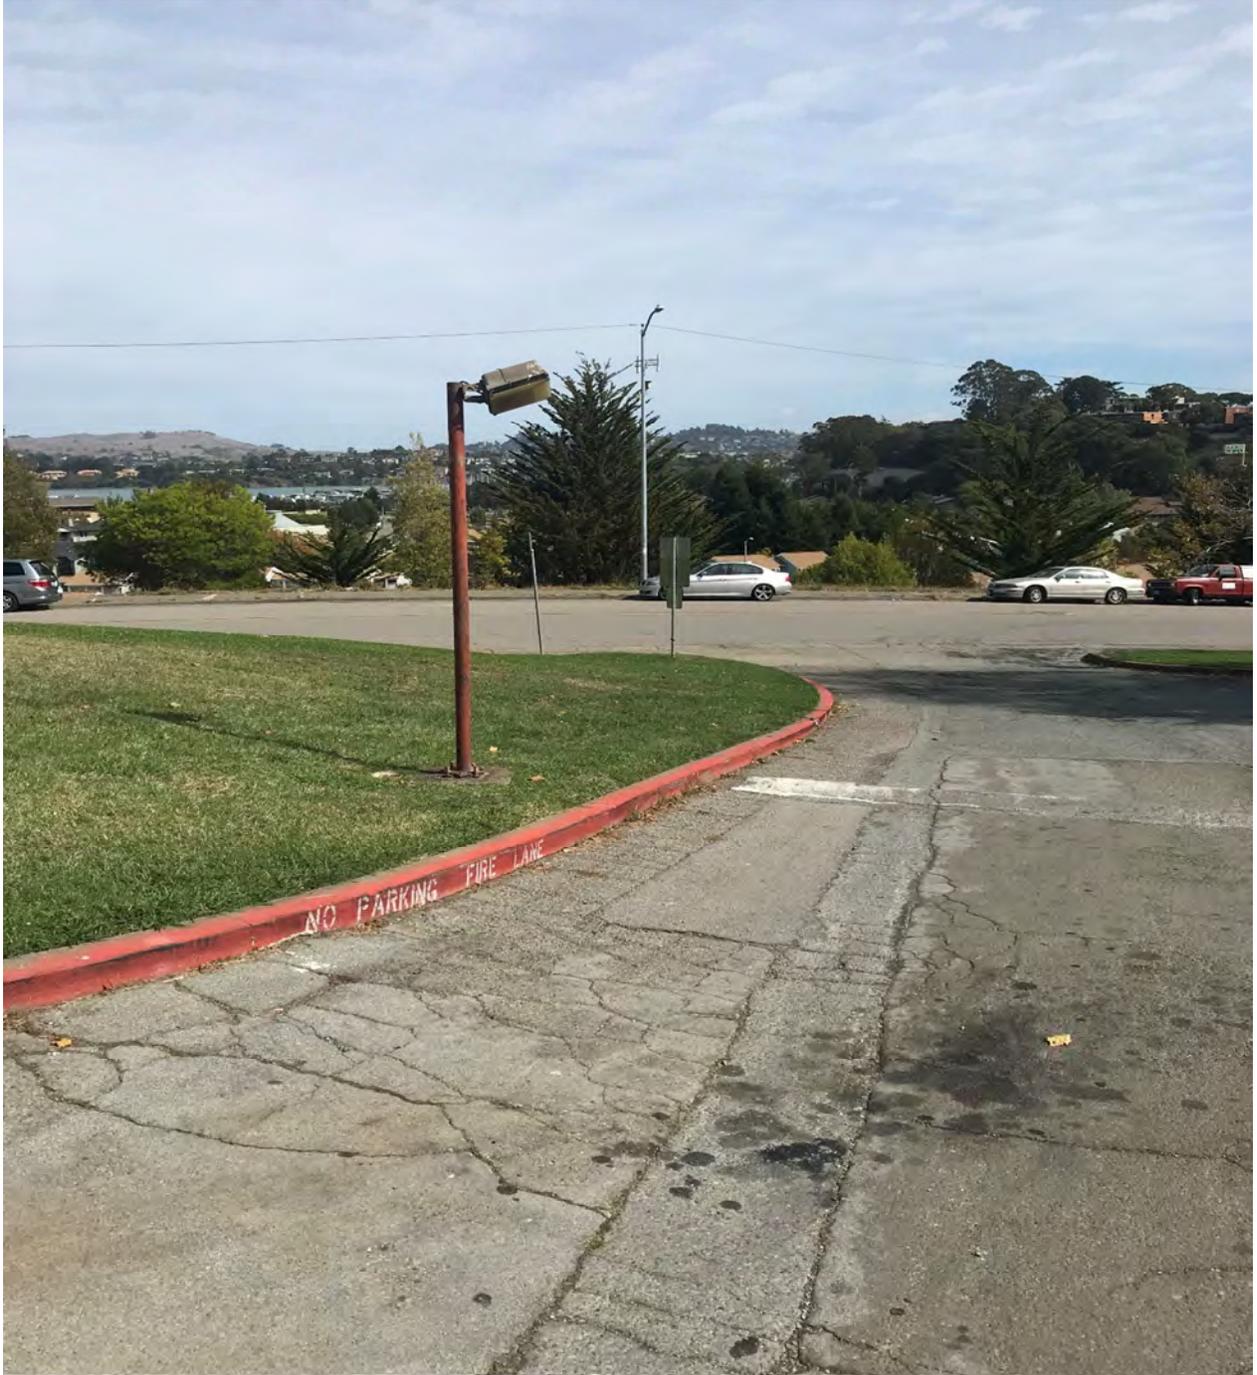
Damaged paving, site light

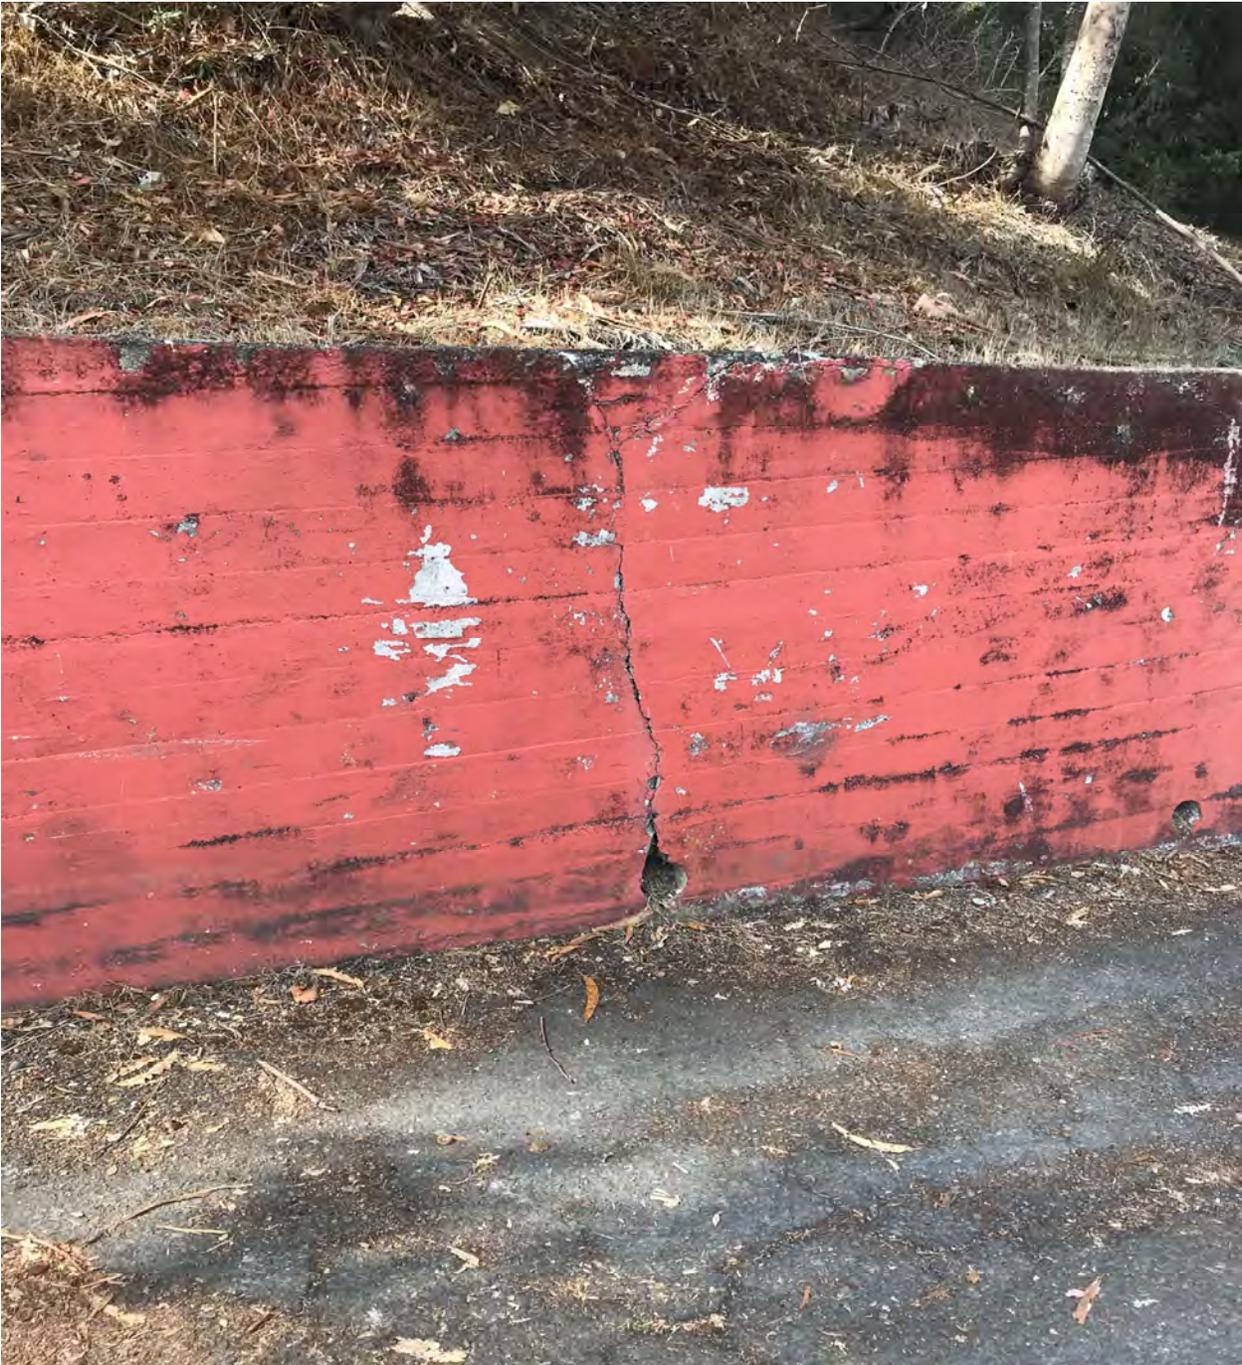
Damaged retaining wall

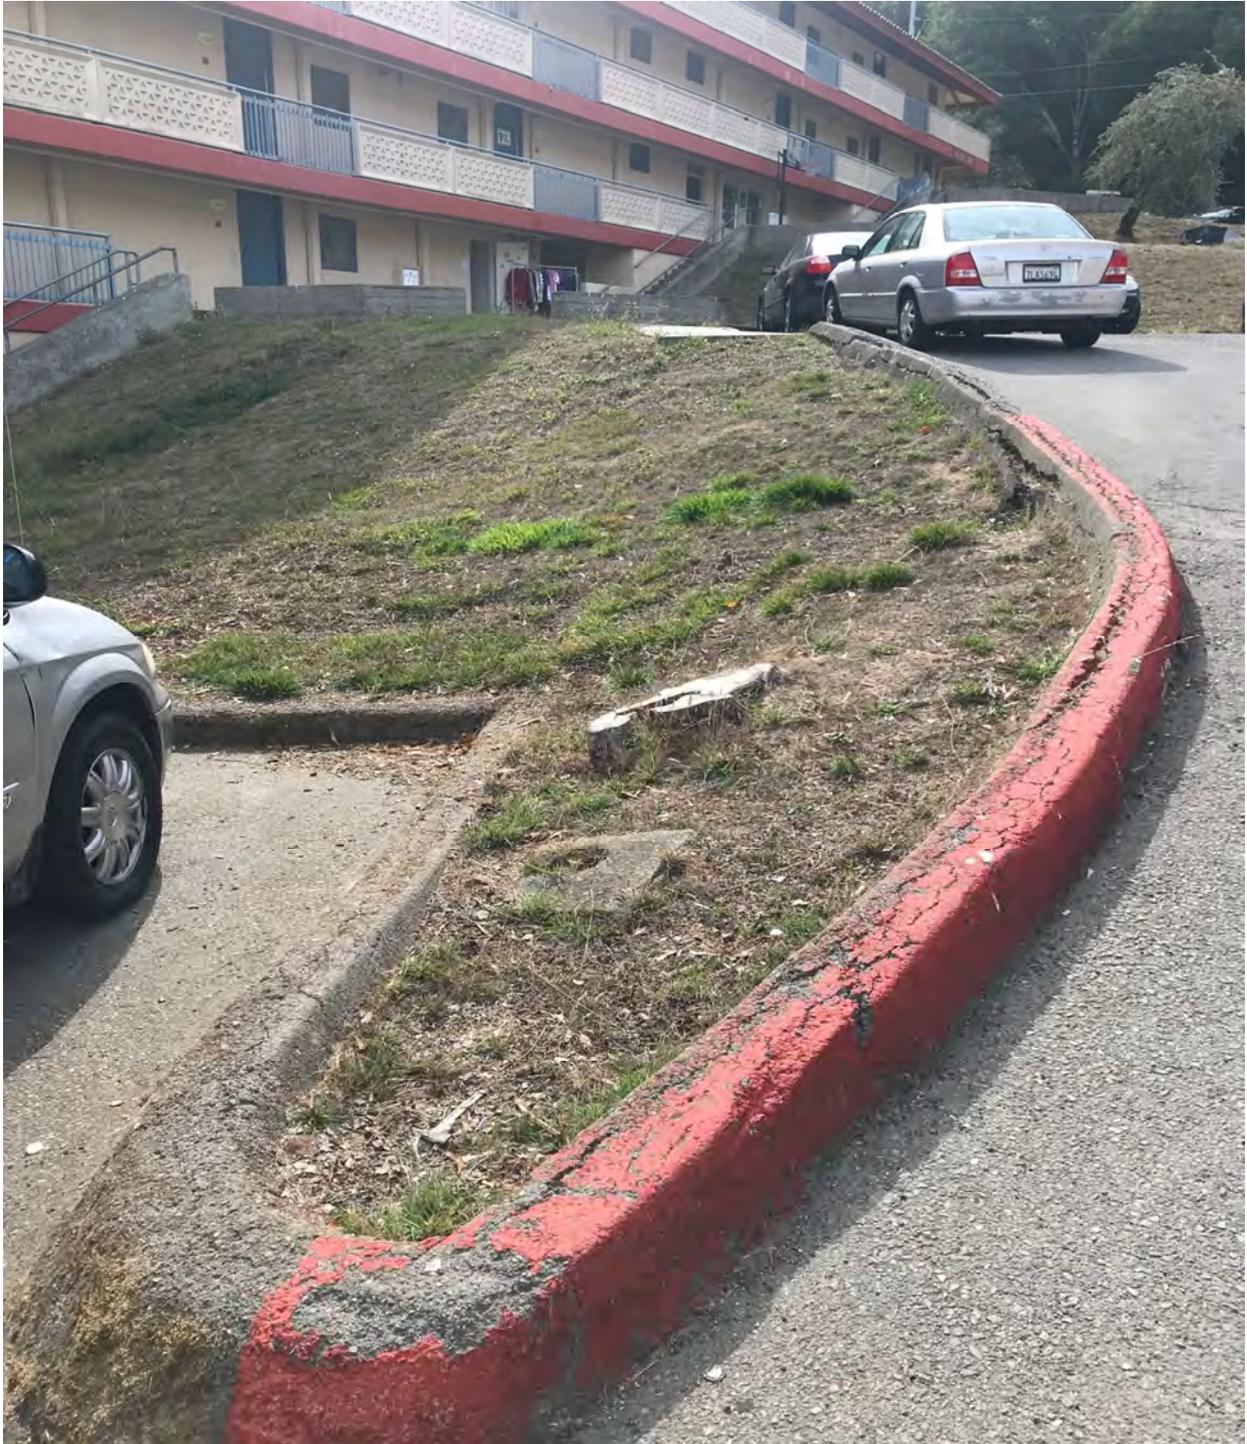
Damaged curb
