THE RESIDENT PLAN

A GOLDEN OPPORTUNITY FOR GOLDEN GATE VILLAGE

Presented by the Golden Gate Village Resident Council

January 25, 2022

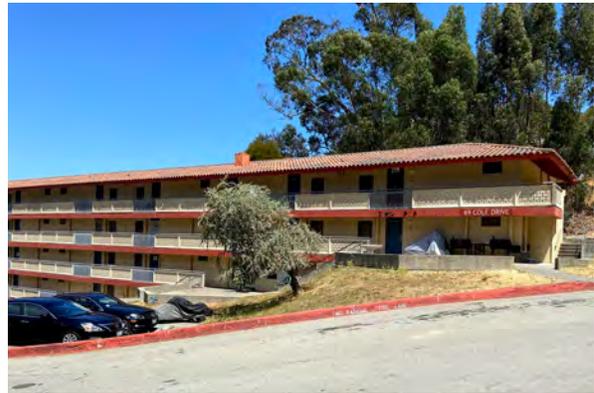
- Roofs were observed from the ground and appear to be in overall fair condition. Building officials and occupants did not report any roof leaks.

Typical Type A roof (69 Cole Drive)

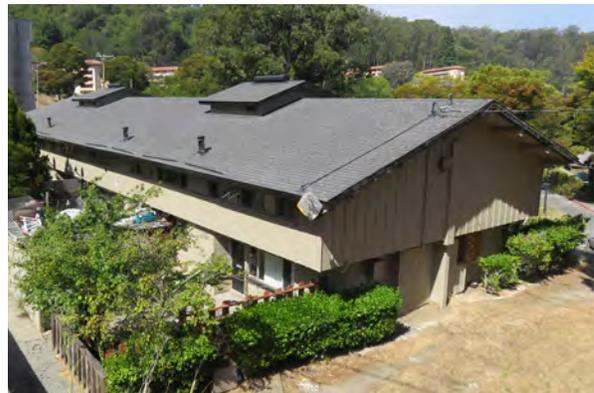
Typical Type B roof (31-45 Cole Ave)

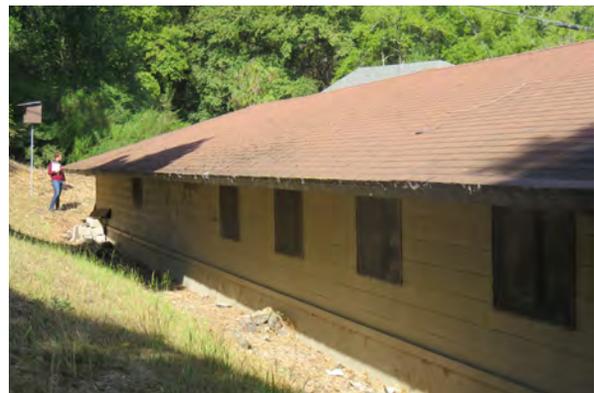
AOMB roof

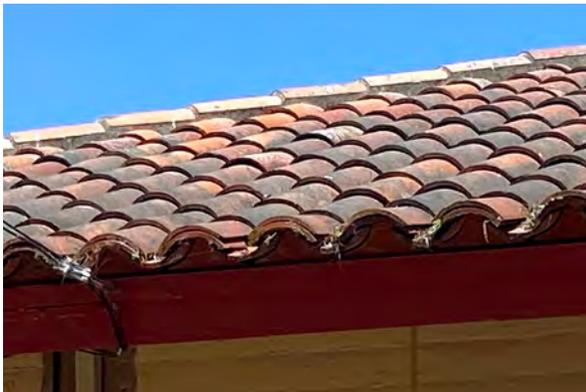
Typical soiling and biological growth on the clay tile roofs of the Type A buildings (79 Cole Drive)

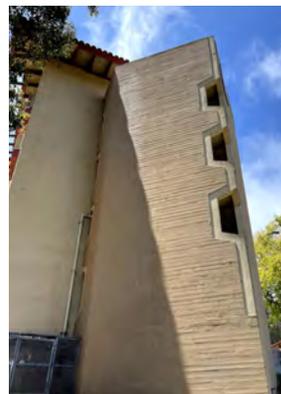
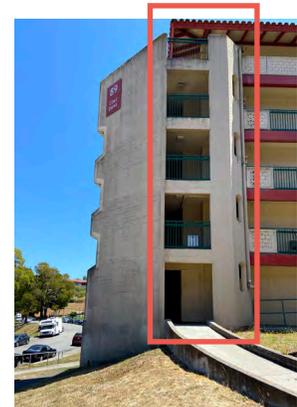
Hexagonal openings in the Type A stairwell walls (left); non-original rectangular and hexagonal openings (right)

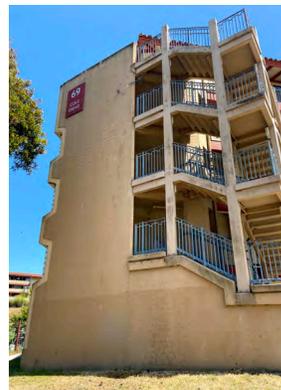
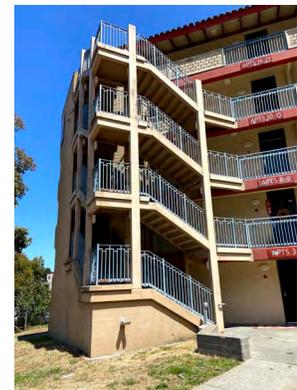
New exposed steel and concrete staircase added to Type A building in 2002 (69 Cole Drive)

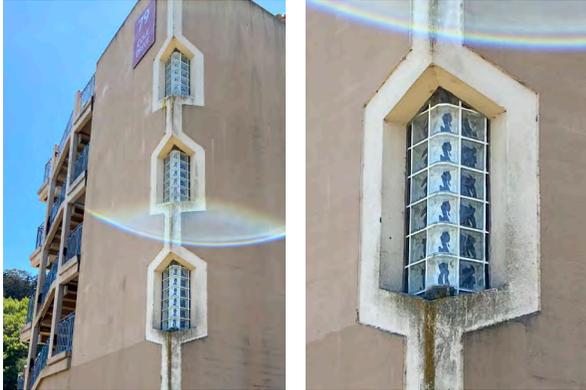
Typical glass block infill modification of the original design at hexagonal openings (Type A - 79 Cole Drive)

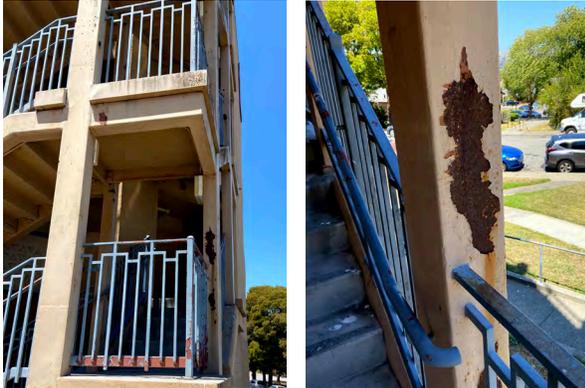
Typical corrosion and paint deterioration at steel-frame staircases (Type A - 79 Cole Drive)

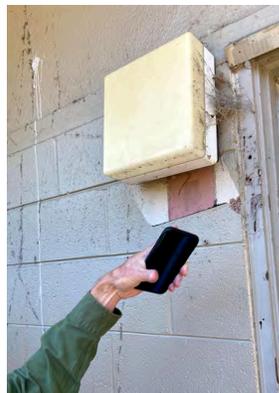
Typical staining on the CMU walls from vine growth and old paint visible at light fixture replacement (Type E - 2-8 Cole Drive)

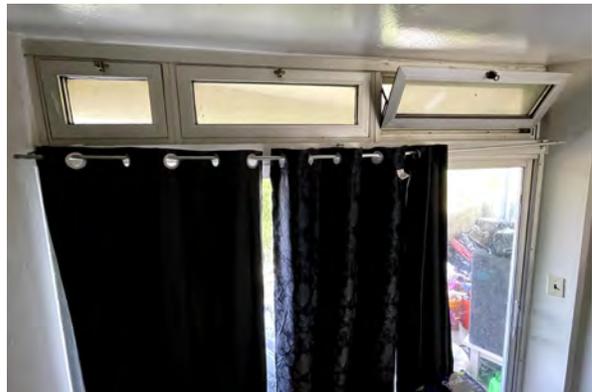
Non-original hopper transoms at Type A apartment terrace window

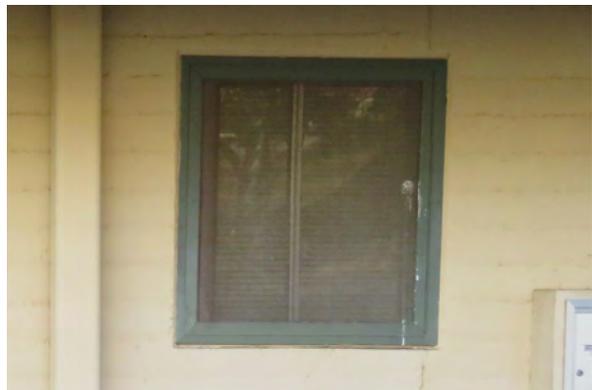
Typical 2-lite sliding window at Type A buildings (49 Cole Drive)

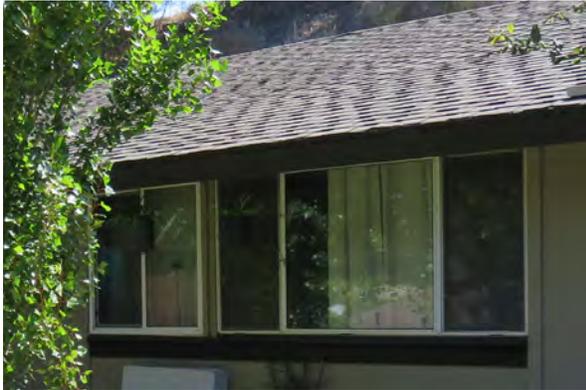
Typical 2- and 3-lite sliding windows of Type C buildings (251-57 Drake Ave)

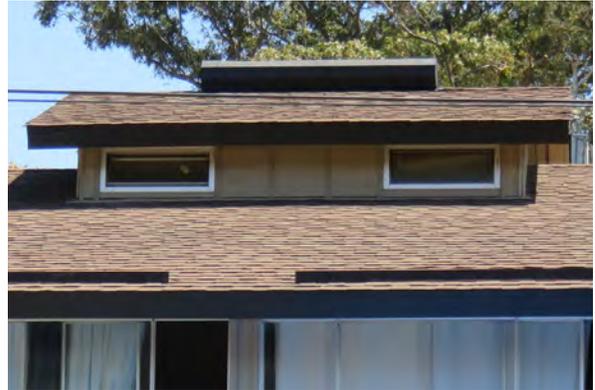
Typical awning windows at Type B buildings (161-75 Drake Ave)

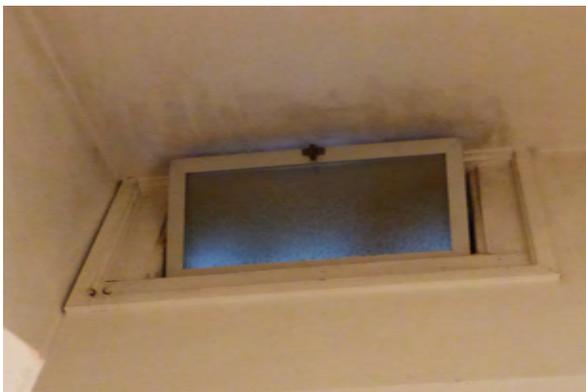
Typical hopper window in a Type E apartment bathroom

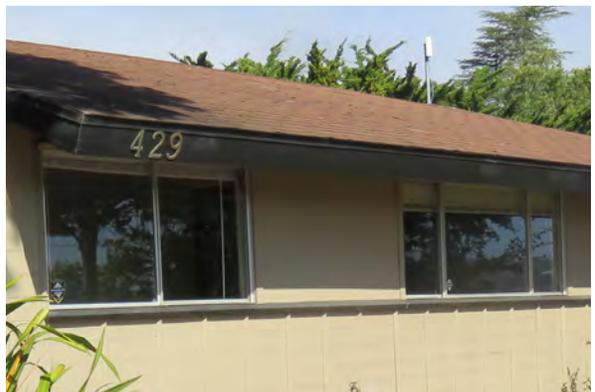
Typical 2- and 3-lite sliding windows of AOMB

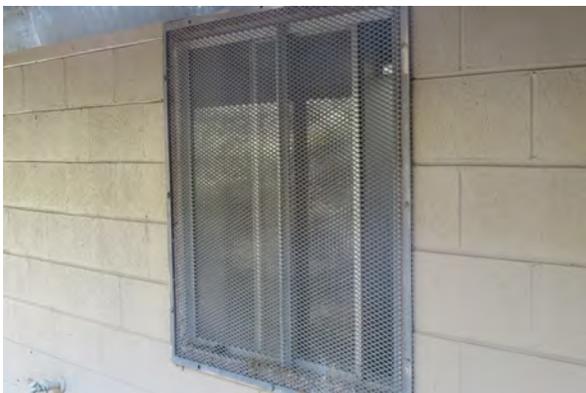
Typical security grill outside a south elevation AOMB window

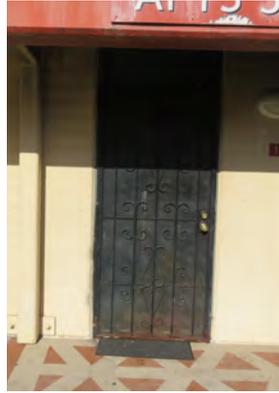
Metal security door (Type A - 59 Cole Drive)

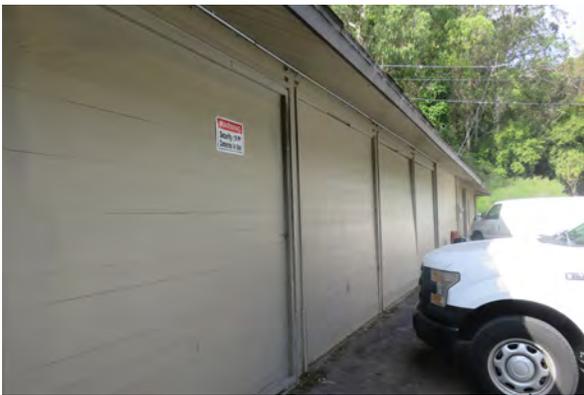
- All doors were observed from the ground, and the condition of some doors was obscured by security doors, fences, and plants.
- The doors are in overall fair condition.
- A variety of different screen door styles and colors were noted.
- AOMB garage doors are in fair condition and are bowed. Exterior wood boards of the doors are no longer flush. They also exhibit paint deterioration at areas closer to the ground.

AOMB garage doors with redwood siding

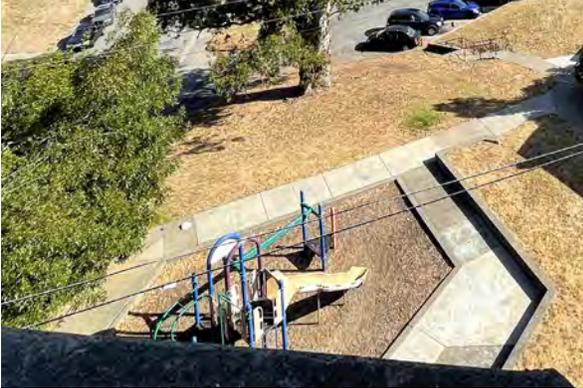
Trapezoid-shaped concrete play area

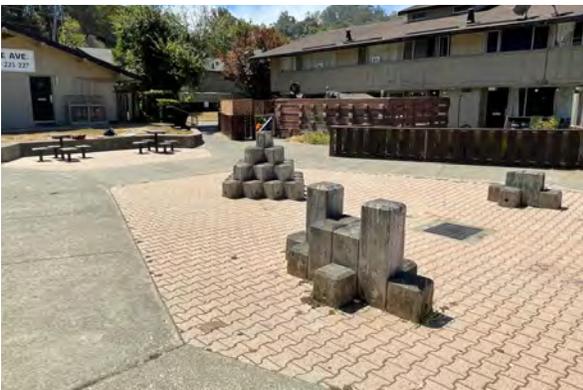
- Built-in wood and steel courtyard table and benches are in poor condition and exhibit loss of material, weathered finish, general soiling, rot, and biological growth. Many are in unusable condition.
- Wood sculptures are in poor condition and exhibit checking, weathered finish, general soiling, and biological growth.

Typical courtyard with concrete pavement, brick pavers, wood sculptures, and wood and steel benches

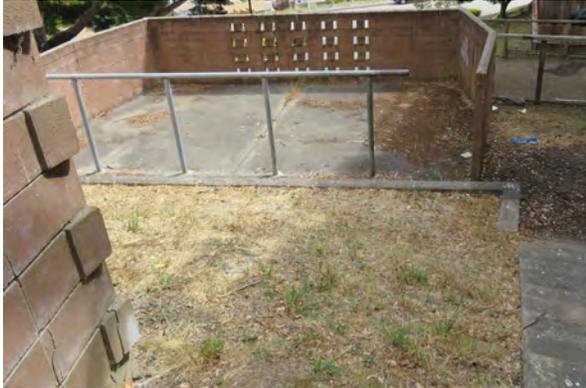
CMU block fence exhibiting cracks, soiling, and biological growth (Type A - 419 Drake Ave)

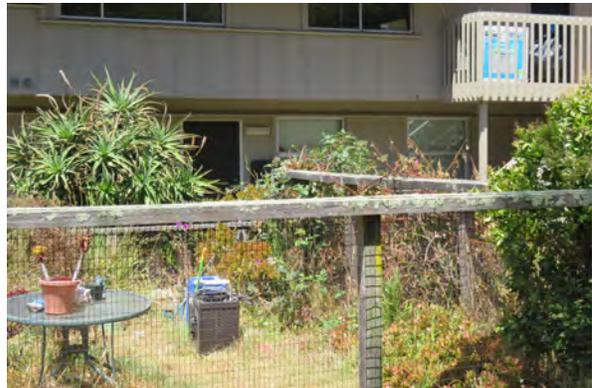
Non-original wood and wire mesh fence (Type B - 101-15 Drake Ave)

- Vertical wood screen fences are in poor condition and exhibit checking, weathered surface, and biological growth.
- Other non-original fences are in fair condition and exhibit checking, weathered surface, and biological growth.

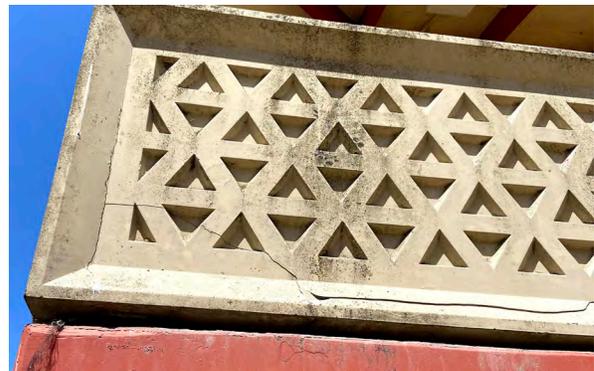
- Original precast concrete screens are in fair condition and exhibit cracks, spalls, general soiling, biological growth, and insect nests.
- Many precast screens have been replaced with steel railings, aesthetically-similar composite panels, or plywood.
- The placement of different railing types varies on each floor of some buildings. Placement seems haphazard and is visually distracting.
- Steel railings are in fair condition and exhibit corrosion and paint deterioration.
- Composite panels are in poor condition and exhibit significant cracks, spalls, and incompatible patch repairs.

Crack in precast concrete screen (Type A - 69 Cole Drive)

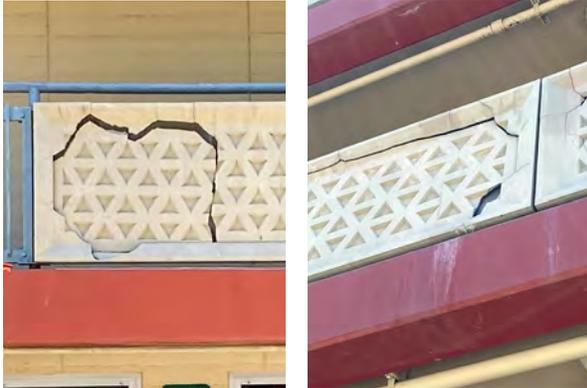
Composite panel failure (Type A - 79 Cole Drive)

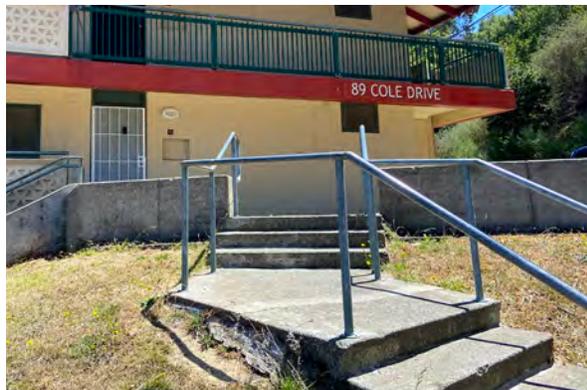
- Metal pipe handrails are in fair condition and exhibit corrosion, paint deterioration, and missing screws.

Metal pipe handrail at a Type A building (89 Cole Drive)

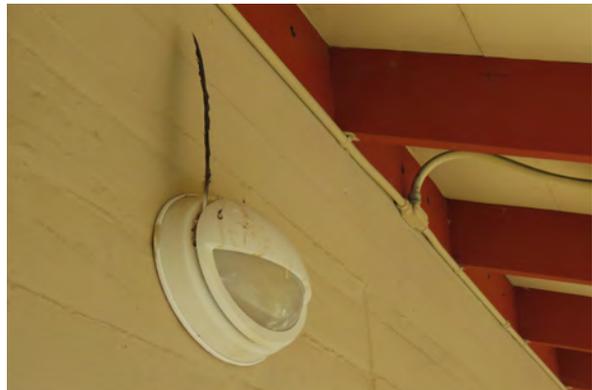
- Surface-mounted rounded, square, and rectangular lights are in fair condition. At several locations, where the fixtures were replaced with a different type, size, or shape, previously painted surface is visible and does not blend with the current paint scheme. Some of the light fixtures are also disconnected.
- Security flood lights are in poor condition. Many are broken and/or missing pieces.

Disconnected light fixture

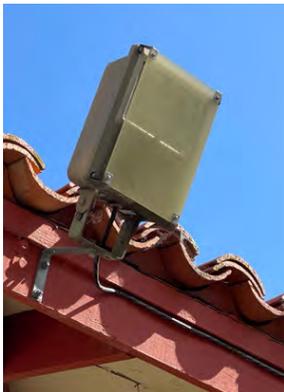
Typical security flood lights

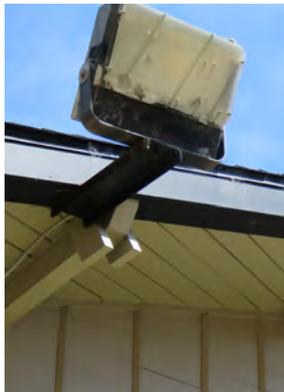
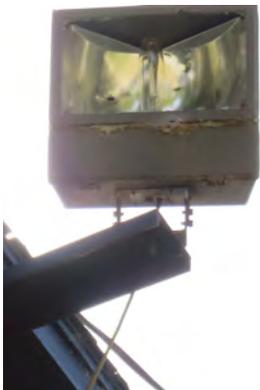
Typical security flood lights

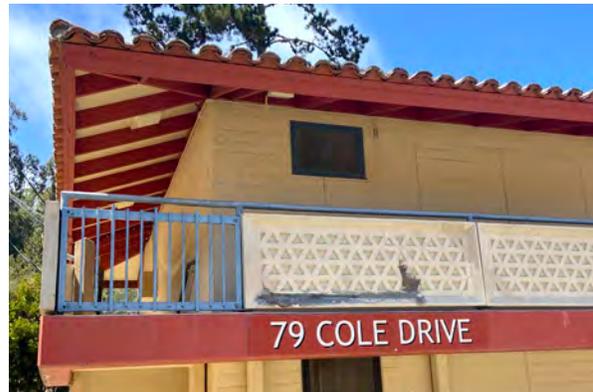
- The exterior signage is in overall fair condition. Many signs are illegible due to paint deterioration or overpaint.

Typical Type A buildings signage; this type of signs do not appear to be original

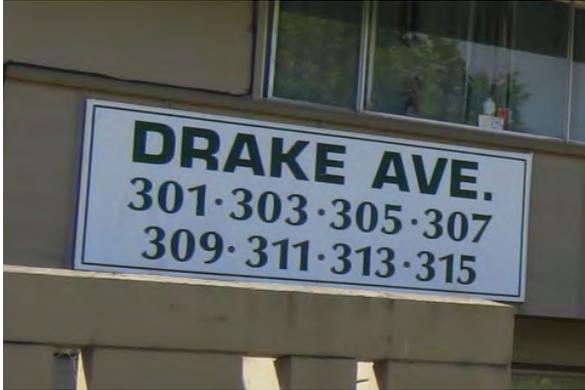
Typical Type B, C, and E buildings signage

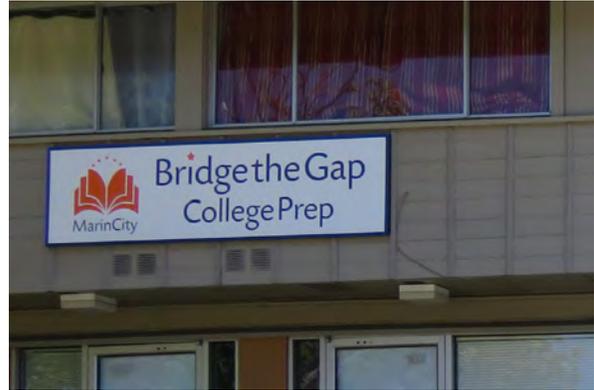
Signage at a unit converted into an office space does not match the general color scheme

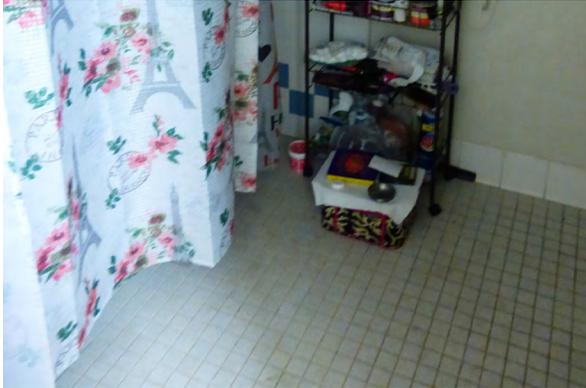
Tile flooring in a Type C apartment bathroom

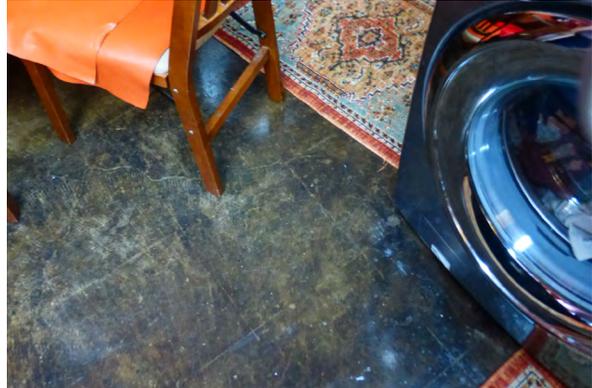
Uncovered concrete floor in a Type C kitchen after resilient tile removal

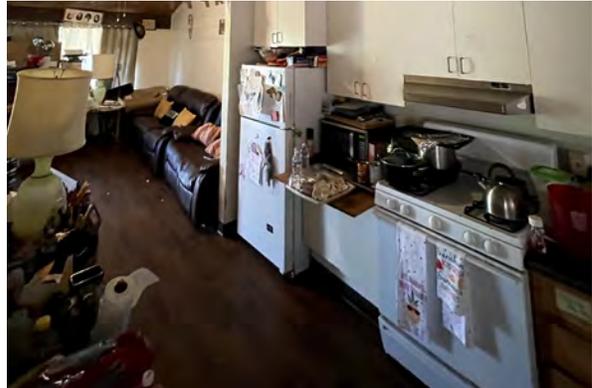
Faux-wood floor in a Type C apartment

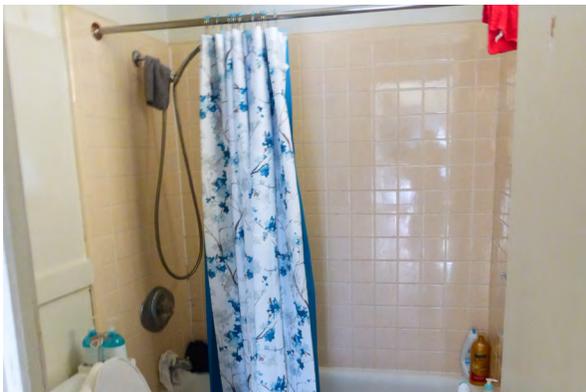
Typical ceramic tile cladding in a Type A bathroom

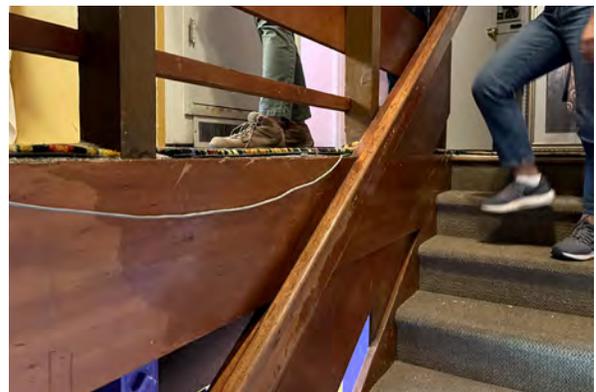
Weathered wood staircase finish at a Type B building apartment

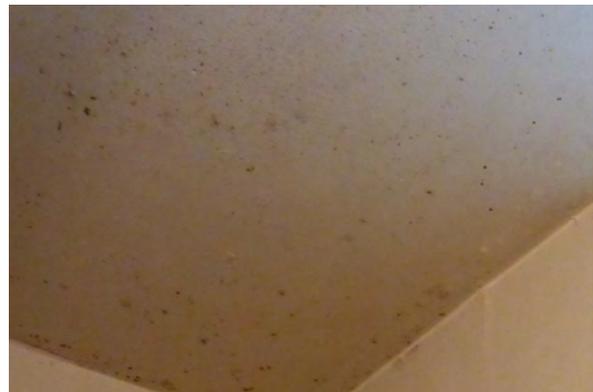
- Interior ceilings are in overall fair condition, with water damage likely due to leaking pipes in some apartments.
- The paint is in overall fair condition and exhibits soiling, stains, and loss in select areas.
- A kitchen exhaust pipe inside a Type E apartment was covered in residue indicating improper ventilation.
- Mold growth was observed in several bathrooms. Operable windows appeared to be the only form of exhaust.

Mildew in the bathroom ceiling of Type A building
